INSTALLATION INSTRUCTIONS

VGUBG-0987-1229SS-20LED

01-07 TOYOTA HIGHLANDER PARTS

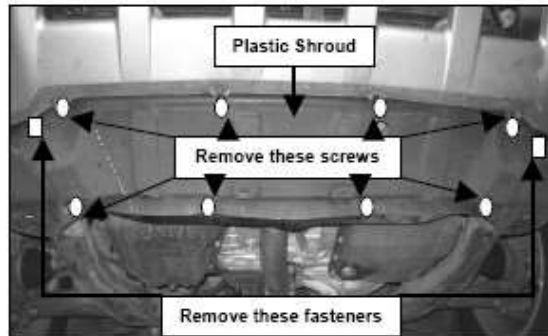
Figure 2

2. Carefully remove the plastic shroud underneath the vehicle by removing the (4) screws on top, (4) screws on bottom, and (1) fastener on each side (Figure 2).

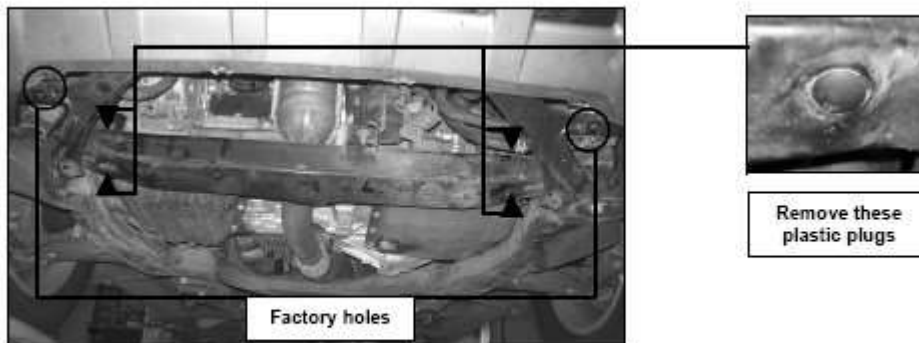
Figure 3

3. Remove the plastic plugs on the cross bar member. There is one on the passenger side and one on the driver side, top and bottom of cross member bar (Figure 3).

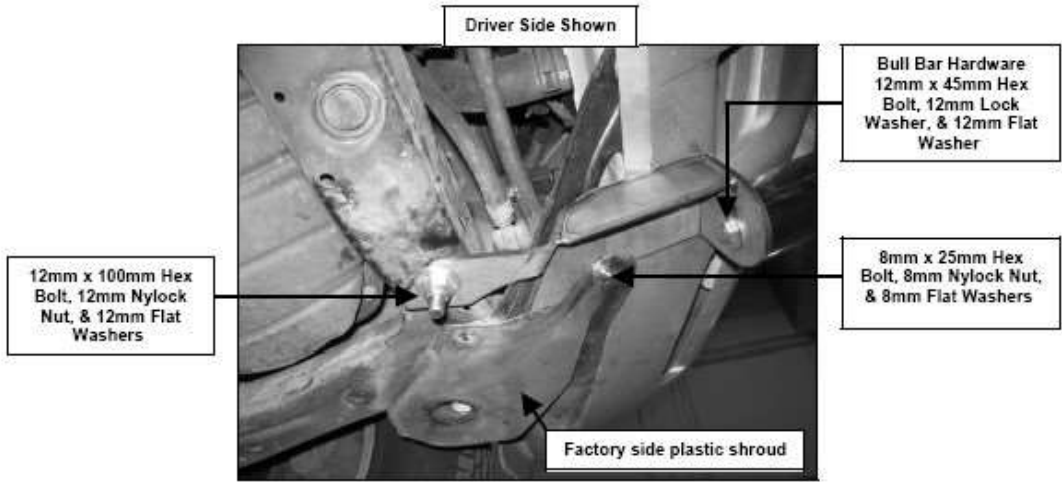
Figure 4

4. Position Driver Side Mounting Bracket to vehicle and align holes on the bracket to factory holes. The rear most hole to the Mounting Bracket mounts to the cross bar member using (1) 12-1.75mm x 100mm Hex Head Bolt, (1) 12mm Nylock Nut, and (2) 12mm Flat Washers. The front hole on the Mounting Bracket mounts to the factory bumper support by using (1) 8-1.25mm x 25mm Hex Head Bolt, (1) 8mm Nylock Nut, and (2) 8mm Flat Washers, use this

hardware to re-attach the side factory plastic shroud (Figure 4). **NOTE:** To ease the installation insert bolts with flat washer listed in this step through the top of the cross bar member and bumper support. Do not tighten at this time. Repeat this step for passenger side.

5. Position Bull Bar onto Mounting Brackets and loosely attach it with the included (2) 12-1.75 x 45mm Hex Head Bolts, (2) 12mm Flat Washers, and (2) 12mm Lock Washers (Figure 4).

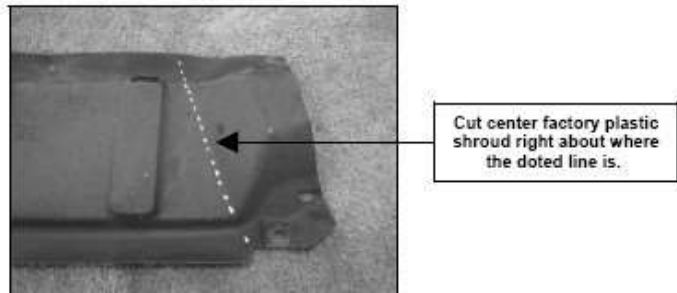
7. In order to re-install the plastic shroud, some cutting is necessary. Once the Bull Bar is fully mounted, place the center plastic shroud to its original position and mark where it needs to be cut (Figure 5). Re-install plastic shroud with factory hardware removed in step 1.
