INSTALLATION INSTRUCTIONS

VGUBG-1173-1229BK

01-07 TOYOTA HIGHLANDER PARTS

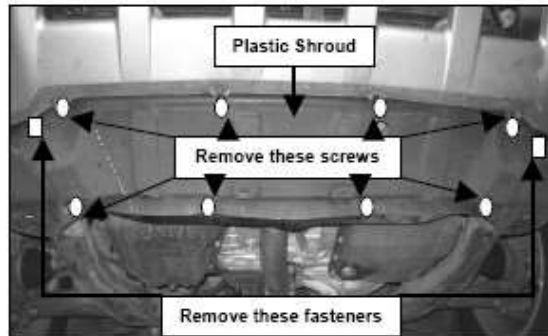
Figure 2

2. Carefully remove the plastic shroud underneath the vehicle by removing the (4) screws on top, (4) screws on bottom, and (1) fastener on each side (Figure 2).

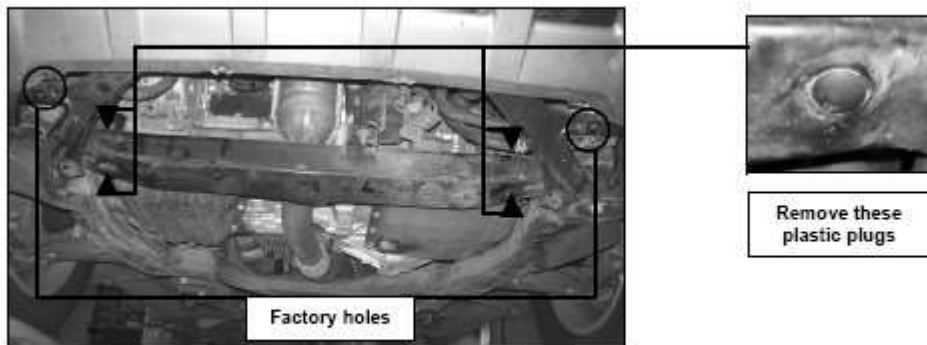
Figure 3

3. Remove the plastic plugs on the cross bar member. There is one on the passenger side and one on the driver side, top and bottom of cross member bar (Figure 3).

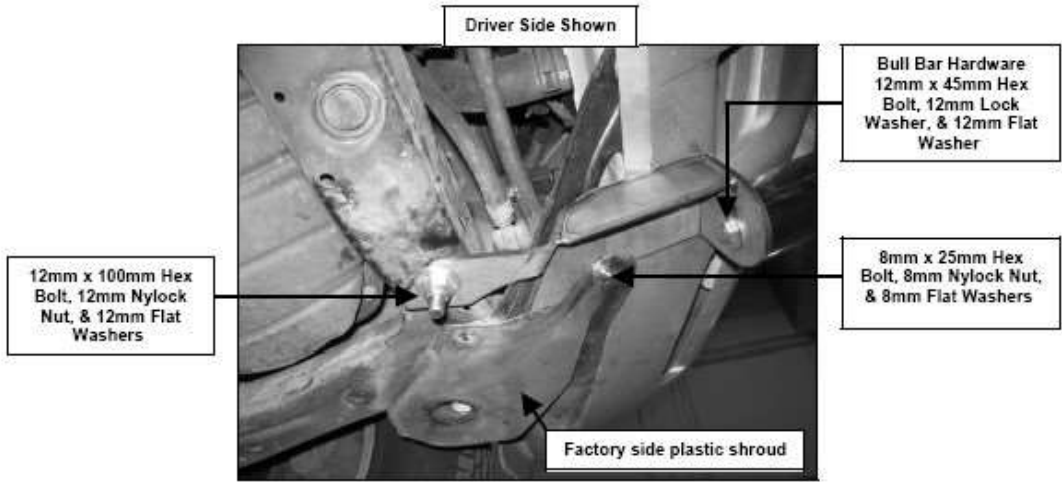
Figure 4

4. Position Driver Side Mounting Bracket to vehicle and align holes on the bracket to factory holes. The rear most hole to the Mounting Bracket mounts to the cross bar member using (1) 12-1.75mm x 100mm Hex Head Bolt, (1) 12mm Nylock Nut, and (2) 12mm Flat Washers. The front hole on the Mounting Bracket mounts to the factory bumper support by using (1) 8-1.25mm x 25mm Hex Head Bolt, (1) 8mm Nylock Nut, and (2) 8mm Flat Washers, use this

hardware to re-attach the side factory plastic shroud (Figure 4). **NOTE:** To ease the installation insert bolts with flat washer listed in this step through the top of the cross bar member and bumper support. Do not tighten at this time. Repeat this step for passenger side.

5. Position Bull Bar onto Mounting Brackets and loosely attach it with the included (2) 12-1.75 x 45mm Hex Head Bolts, (2) 12mm Flat Washers, and (2) 12mm Lock Washers (Figure 4).

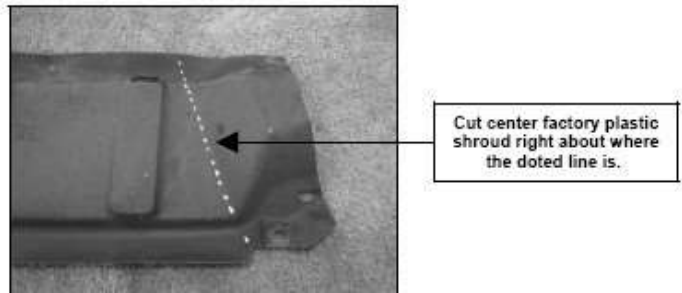
7. In order to re-install the plastic shroud, some cutting is necessary. Once the Bull Bar is fully mounted, place the center plastic shroud to its original position and mark where it needs to be cut (Figure 5). Re-install plastic shroud with factory hardware removed in step 1.
