# **INSTALLATION INSTRUCTION**

#0453/0665

# Bull Bar or Sport Bar 06-18 Toyota RAV4 , 15-20 Lexus NX200T NX300H

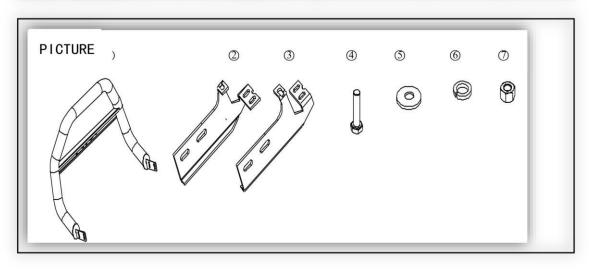
NO.	DESCRIPTION	QUANITY	MEASURE	NO.	DESCRIPTION	QUANITY	MEASURE
①	GRILL GUARD	1		5	FLAT WASHER	8	12mm
2	BRACKET L	1		6	SPRING WASHER	4	12mm
3	BRACKET R	1		0	HEX NUT	4	M12
4	HEX BOLT	4	M12X35

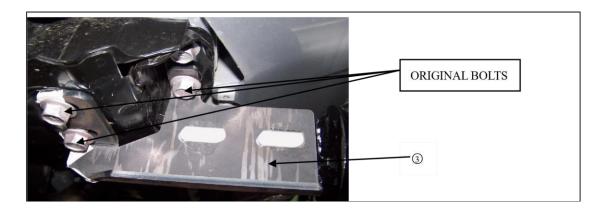
- 1、 REMOVE THE FRONT SKID PLATE. THEN SEE THE ORIGINAL BOLTS AS BELOW.
- 2. REMOVE THE ORIGINAL BOLTS, AND INSTALL THE RIGHT BRACKET ( SAME INSTALLING WAY FOR THE LEFT BRACKET).

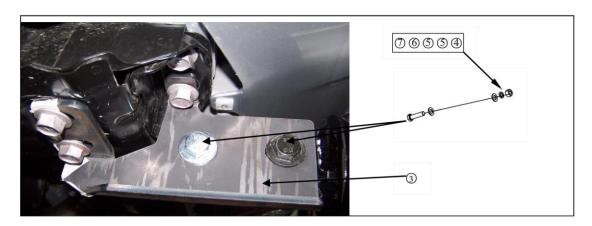
3、INSTALL ① WITH BRACKETS AND TIGHTEN BOLTS. SEE THE PICTURE BELOW.
