INSTALLATION INSTRUCTIONS

VGUBG-1173-1229BK-LED

01-07 TOYOTA HIGHLANDER PARTS

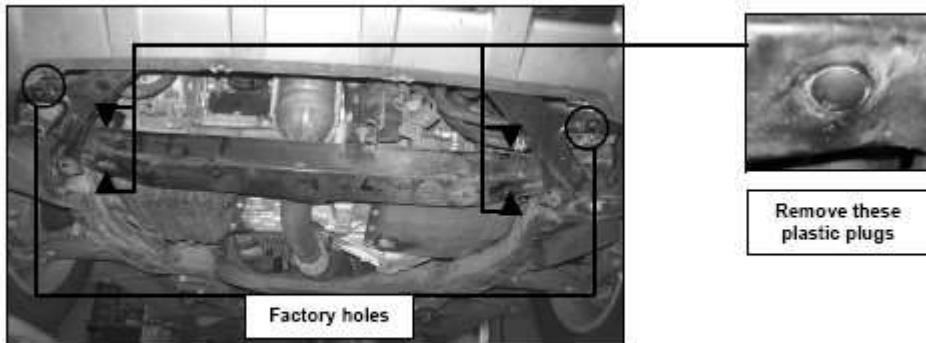
Figure 3

3. Remove the plastic plugs on the cross bar member. There is one on the passenger side and one on the driver side, top and bottom of cross member bar (Figure 3).

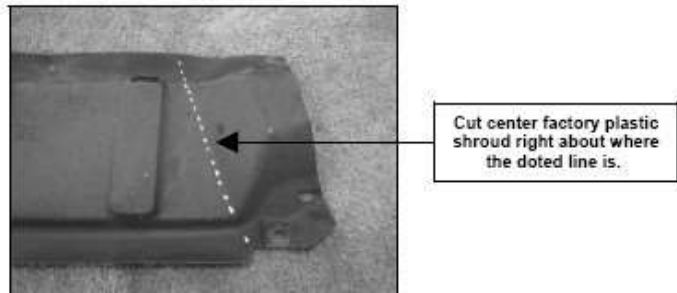
7. In order to re-install the plastic shroud, some cutting is necessary. Once the Bull Bar is fully mounted, place the center plastic shroud to its original position and mark where it needs to be cut (Figure 5). Re-install plastic shroud with factory hardware removed in step 1.
