INSTALLATION INSTRUCTIONS

VGUBG-0987-1229SS-LED

01-07 TOYOTA HIGHLANDER PARTS

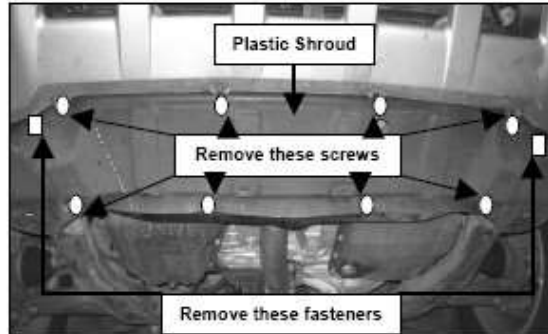
Figure 2

2. Carefully remove the plastic shroud underneath the vehicle by removing the (4) screws on top, (4) screws on bottom, and (1) fastener on each side (Figure 2).

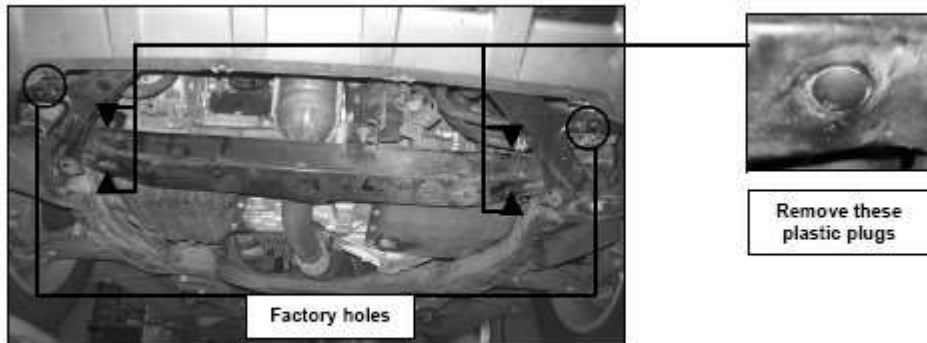
Figure 3

3. Remove the plastic plugs on the cross bar member. There is one on the passenger side and one on the driver side, top and bottom of cross member bar (Figure 3).

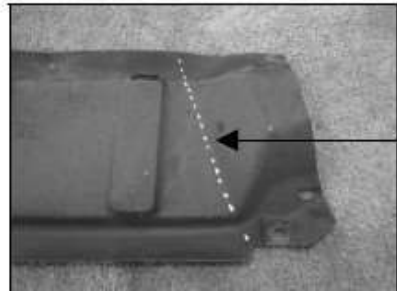
7. In order to re-install the plastic shroud, some cutting is necessary. Once the Bull Bar is fully mounted, place the center plastic shroud to its original position and mark where it needs to be cut (Figure 5). Re-install plastic shroud with factory hardware removed in step 1.
